CENTERVILLE, GEORGIA

2018 HOUSING ASSESSMENT

Prepared by the Middle Georgia Regional Commission

February 2018

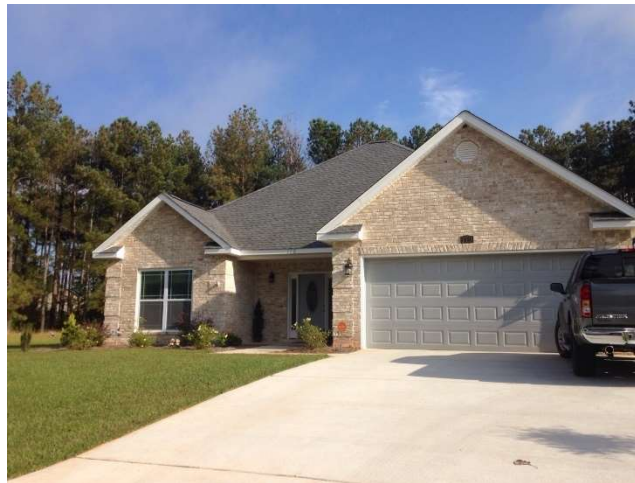
Excellent

The following house is well-maintained with no visible signs of deterioration or defect. It is rated as an excellent house.

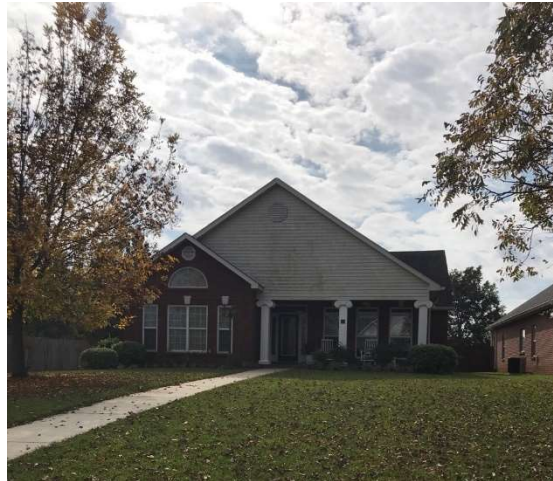
Good

This house exhibits two level-one defects. To be considered an excellent house, the front of the house would need to be cleaned (perhaps power washed). There are many leaves in the front yard but given that yard appearance can change relatively quickly—e.g., the owners may have planned to rake leaves the weekend after this picture was taken—the main issue here is the front of the house.

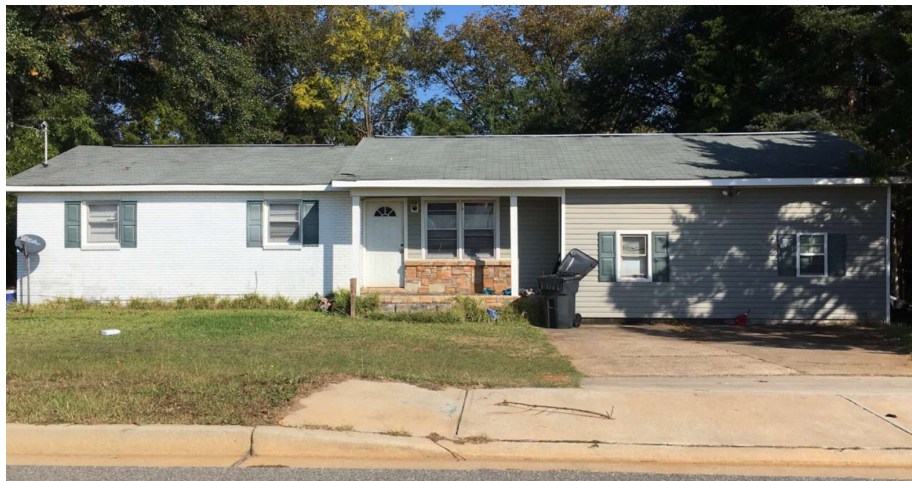
Average

The following house exhibits three level-one defects (average houses may alternatively exhibit one to two level-two defects). If the spot on the roof (to the right of the door) were to be fixed, the front yard weeded, and the shutters repainted, this house would be categorized as an excellent house.

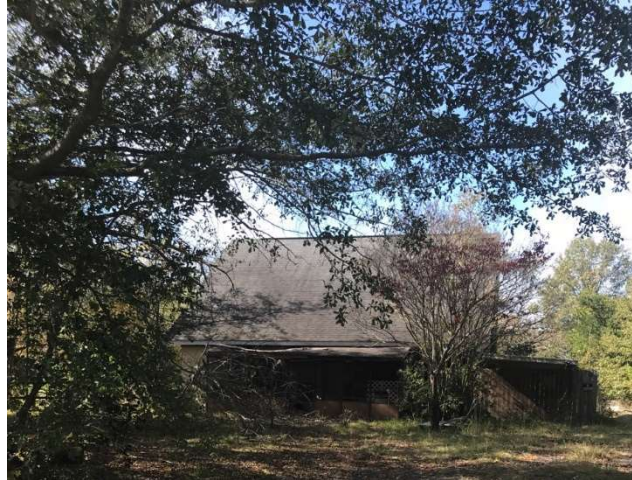
Distressed

This house suffers from at least one level-two and one level-three defect. In particular, the roof over the porch is visibly sagging and the front yard is slightly overgrown. If both of these items were addressed, the house would be recategorized as excellent (assuming no other underlying issues).

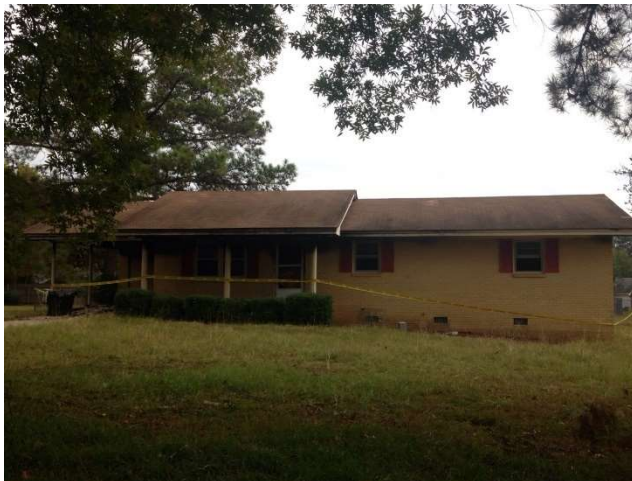
Failing

This house has suffered fire damage. As a result, the roof is damaged, the house is not secure, and the entrance is not accessible.
